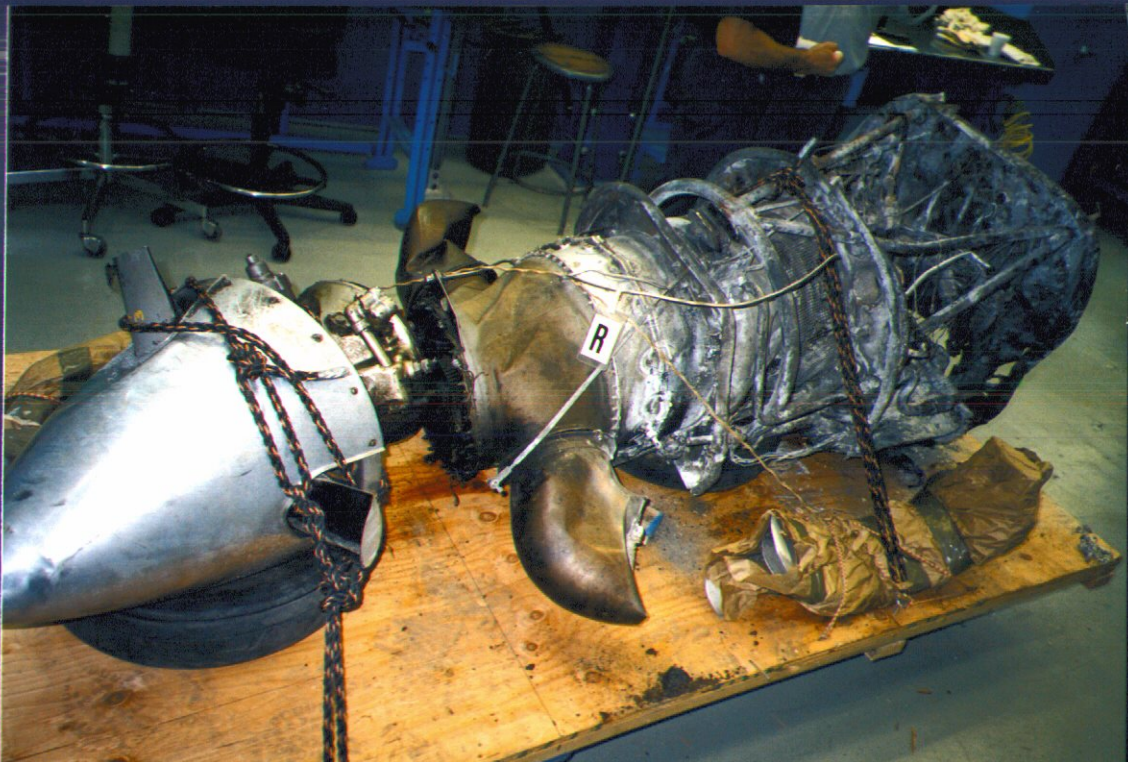
Photo 16: View of right engine as received at engine inspection facility.
